Dear BioNova Partners & Customers,

Summertime means time for vacations! And what are vacations without swimming? So in this current newsletter we want to show you a BioNova Minipool which certainly puts you into vacation mood. Furthermore, we will introduce to you BioNova partner Sechser GmbH from Karlsfeld, Germany, near Munich. And as mentioned in our last newsletter, we will explain how the 100 % biological water treatment in a BioNova NSP works. Last but not least, the BioNova Historical column will feature an NSP built in 1995 for an Austrian hotel. Enjoy reading!
Your BioNova Global Head Office Team

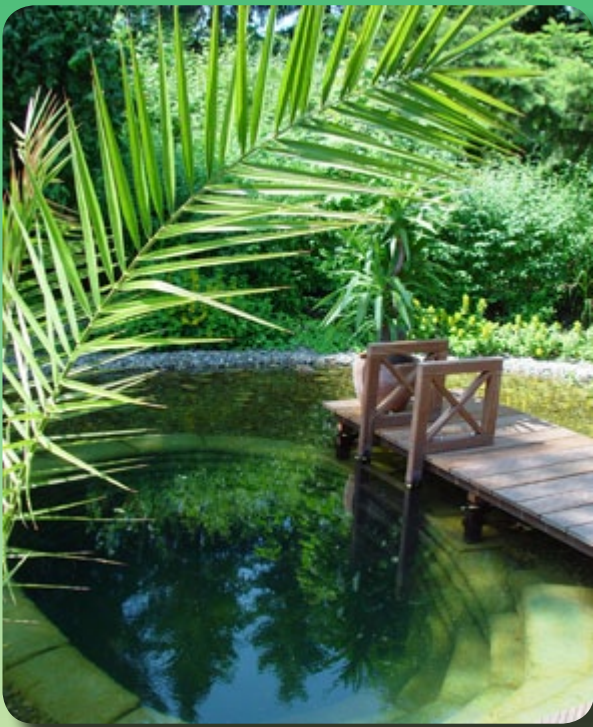
Project of the month

Our long-time partner "Garten- und Landschaftsbau Zinke" based in Arenshausen (Thuringia / Germany) has proven since 2002 that lack of space is no reason to go without an NSP. He answered his client's requests for a little vacation paradise in his own yard in Northeim (Lower Saxony / Germany) by building a small BioNova Minipool that measures only 614 ft².

Swimming area and regeneration zone are not separated in this pool. The oval swimming area is about 6 ½ ft. deep, bordered by granite stones and surrounded by the planted regeneration area, where the used water is cleaned purely by biological processes, without chemicals. Overflow gutters, fine filter and a small circulation pump provide a little added filtration help.

Traverse the regeneration area over a footbridge to the swimming area where a small wooden terrace invites you to relax and stay awhile. Go on vacation - at home - anytime you like!
